Field Visit Report  
Bundala Wewa Rehabilitation (Phase II – CSIAP)  
Southern Province

## FIELD VISIT REPORT

### BUNDALA WEWA TANK REHABILITATION (PHASE II – CSIAP)

**Project:** Climate Smart Irrigated Agriculture Project (CSIAP) – Phase II

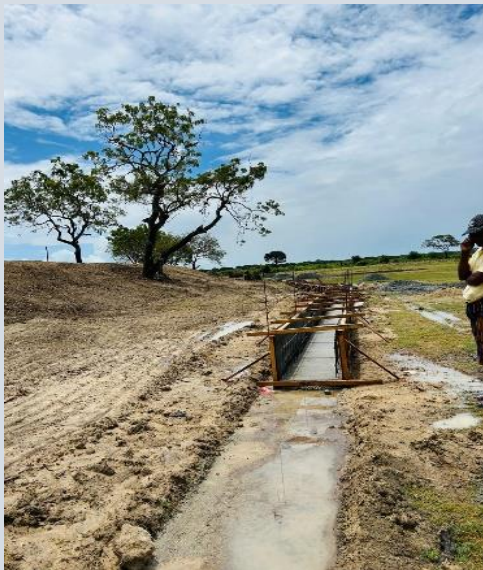
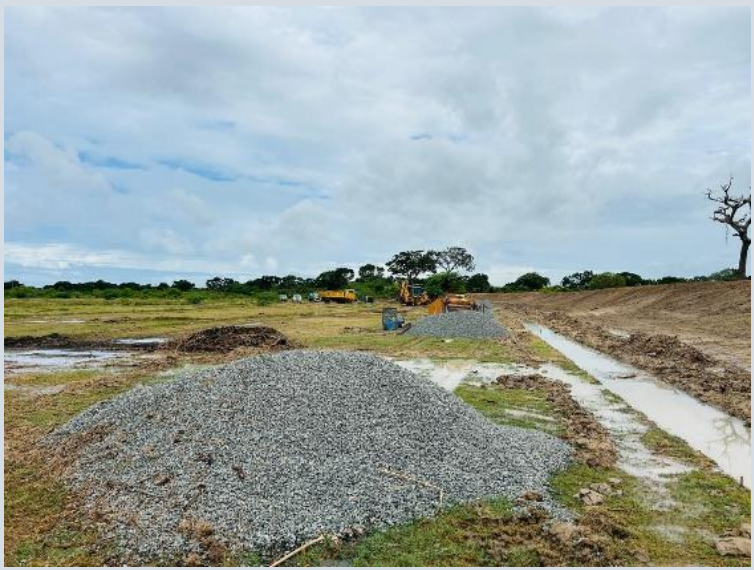
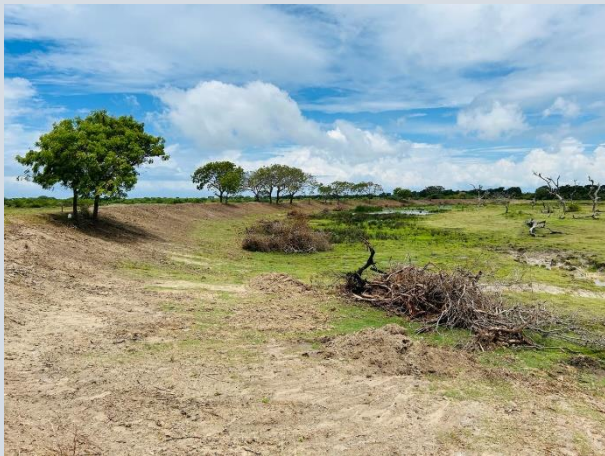
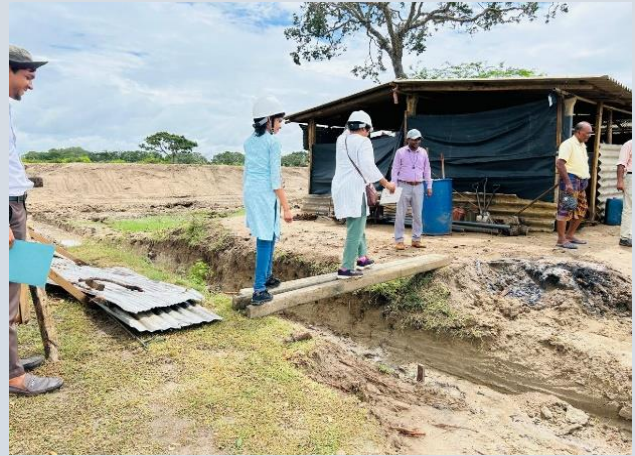
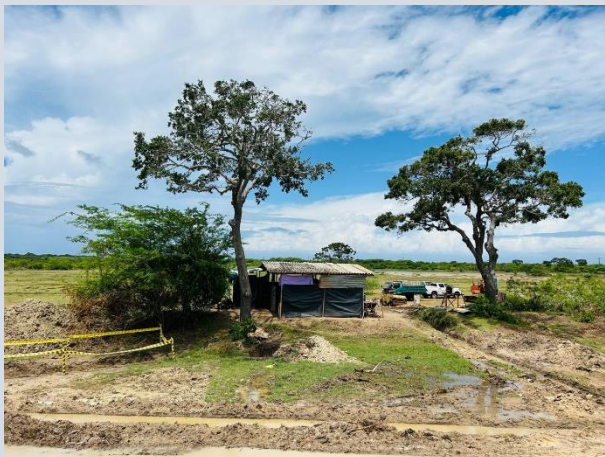
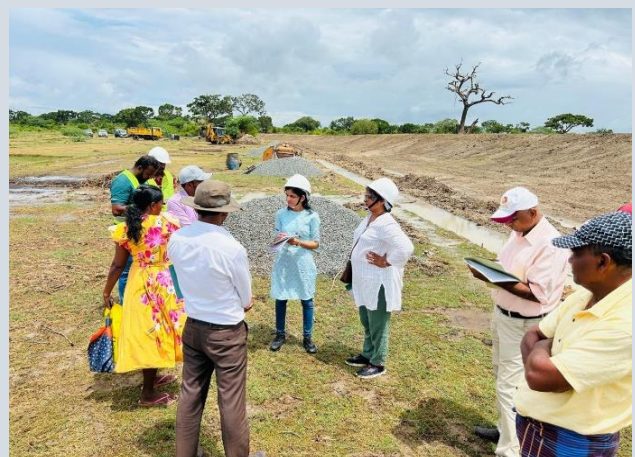
1. Construction Status: Work began on 2nd May 2025. Currently, canal works are in progress, although temporarily halted due to heavy rain.

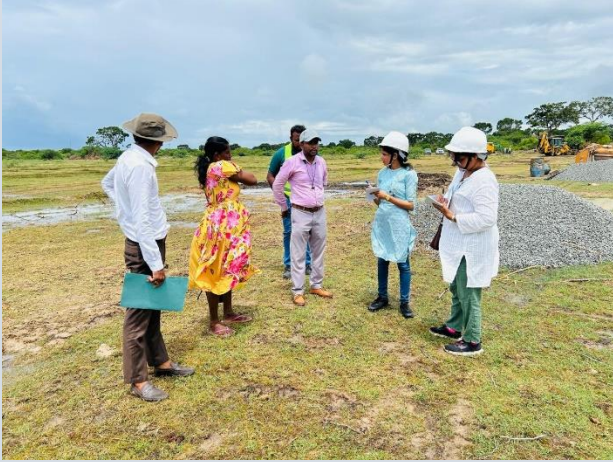
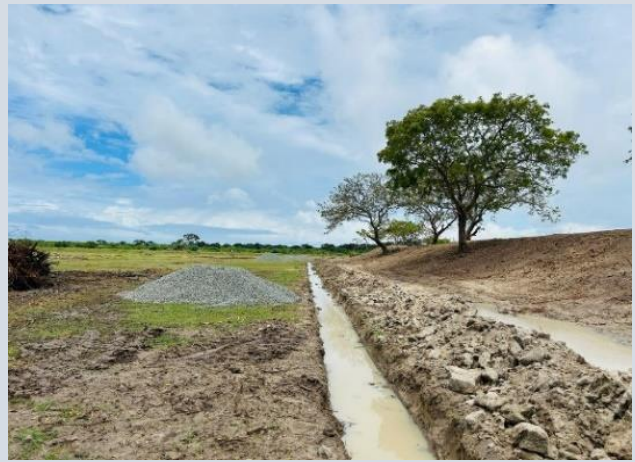
2. Construction materials are stored on-site but, due to rain and flooding, materials are dropped midway to the site within the wildlife boundary as full delivery by heavy vehicles (tippers) is not feasible.

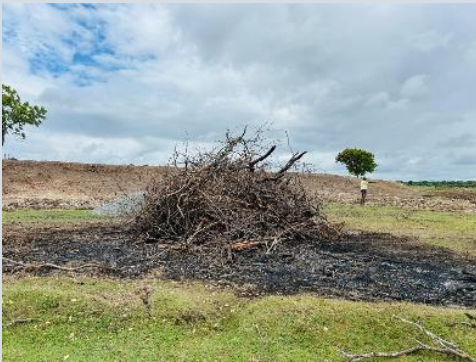
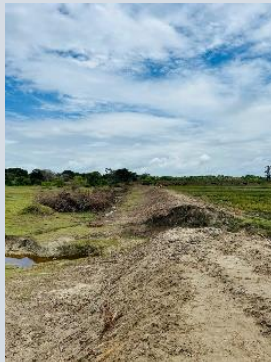
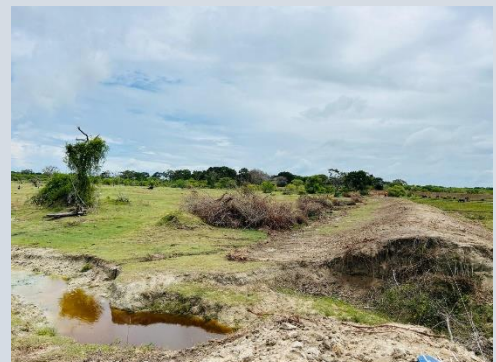
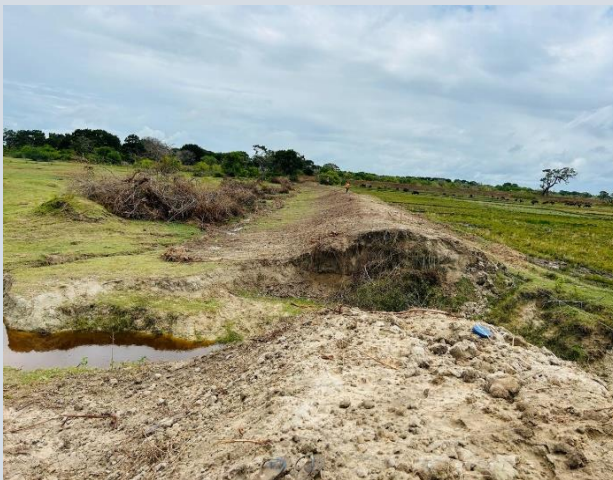
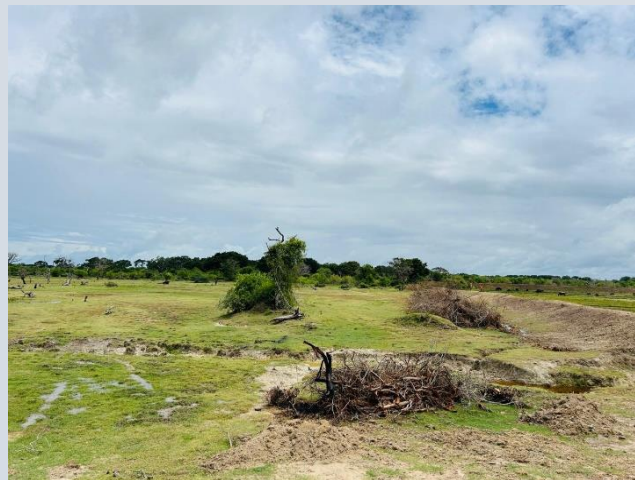
3. Slight vegetation clearance and site clearing were observed.

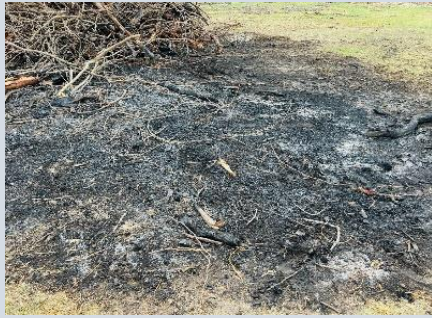
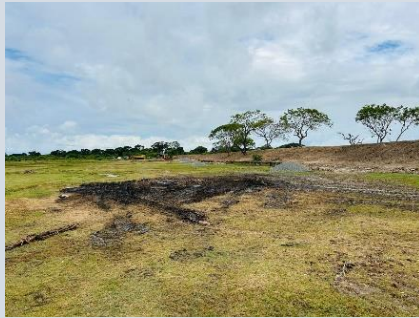
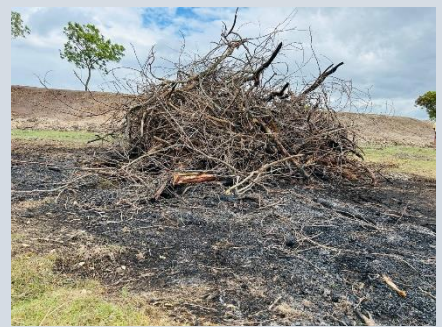
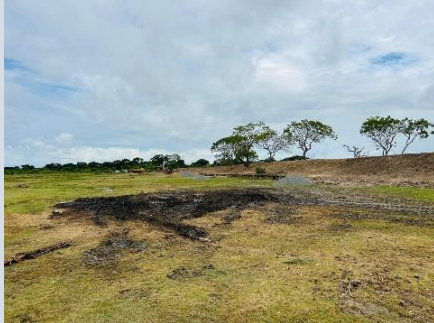
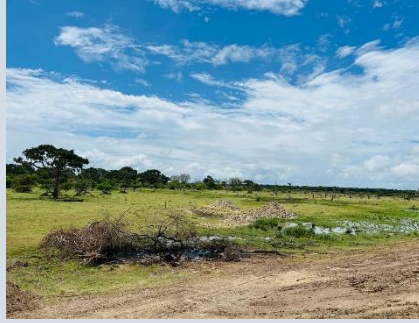
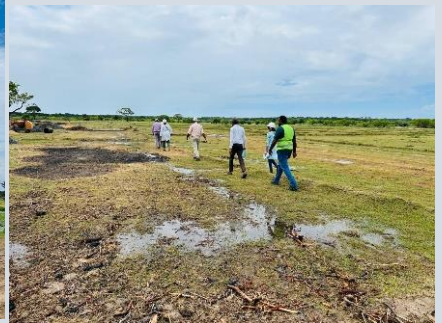
4. Vegetation burning was noticed in some areas, which must be stopped immediately.

Contractors must be formally advised and subjected to close monitoring to prevent any future incidents of burning. Regular site supervision by safeguard officer is essential to ensure compliance with E&S standards.

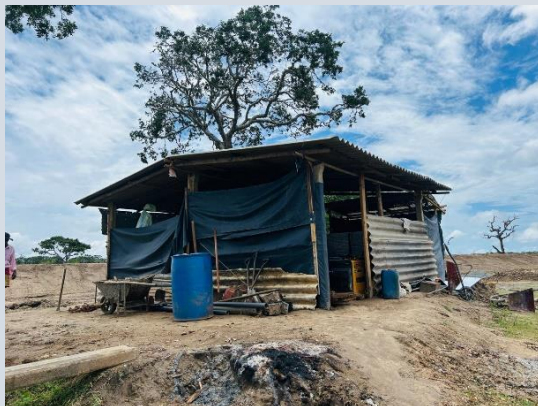
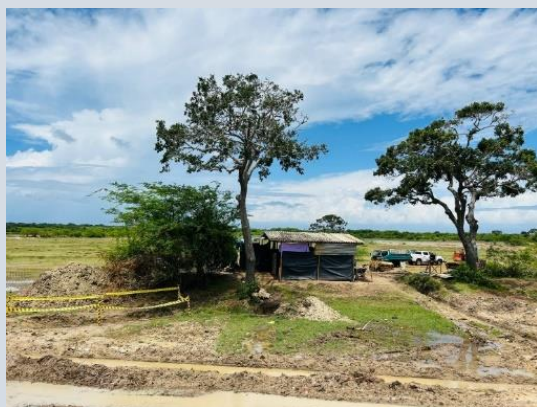
5. Temporary campsite is established. Workers do not stay overnight at the worksite.

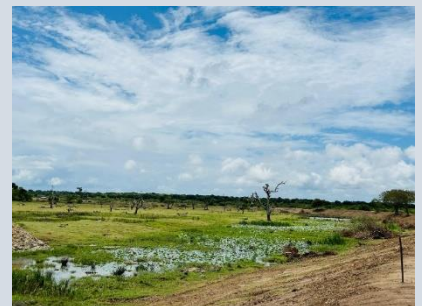
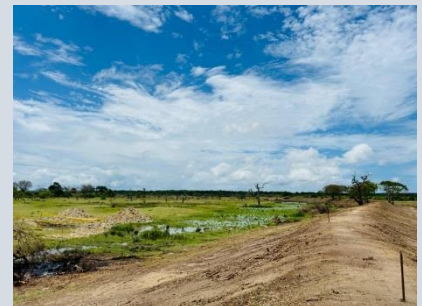
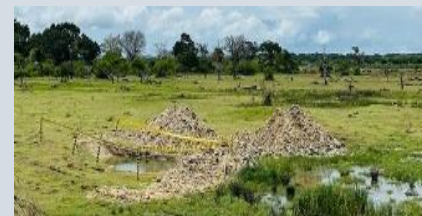
6. No fishing activities are present in the tank. Temporary water feeding well (30ft diameter) was established inside the tank to supply water to wild animals during the rehabilitation period. This well is clearly marked and is a commendable practice. It is identified as sustain Wildlife-Friendly Practices.

The temporary wildlife water feeding well should be maintained until the full rehabilitation of the tank is completed. Communication between the contractor and wildlife officers should be sustained and to ensure continued adherence to the requirements of the Department of Wildlife Conservation (DWLC).

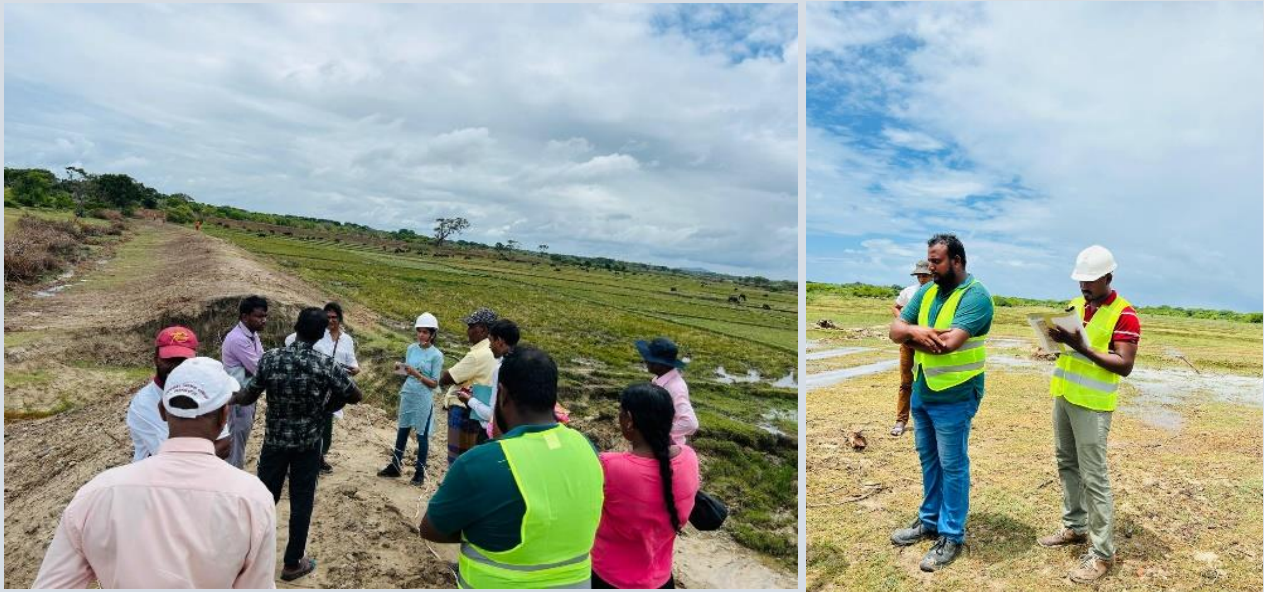
7. Quality Assurance Inspector also functions as the safety officer in the absence of the designated safety officer.

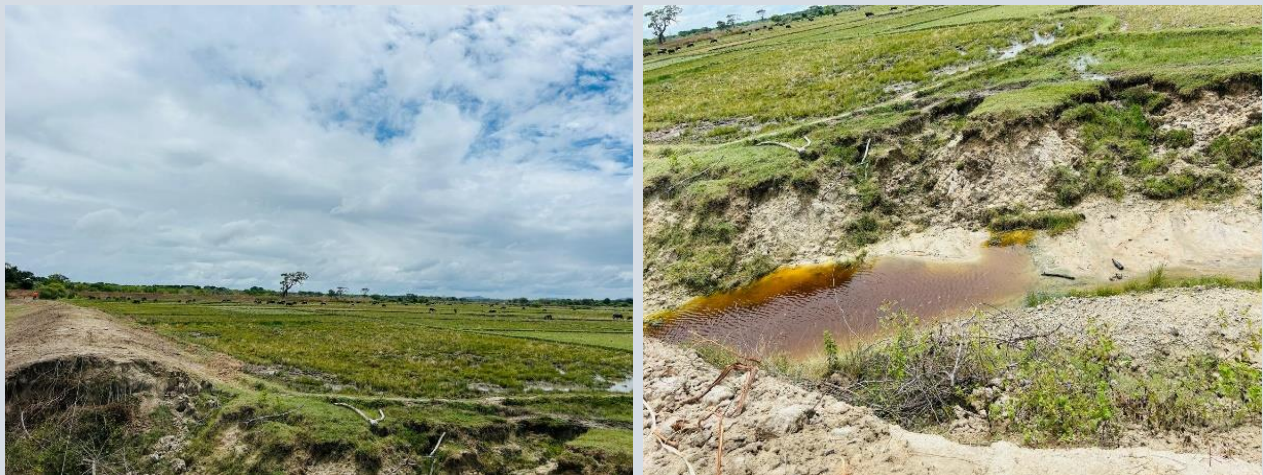
8. Tank Issues and Wildlife Consideration: The tank bund had severe leakage before the tank rehabilitation commences, damaging one farmer's land heavily.

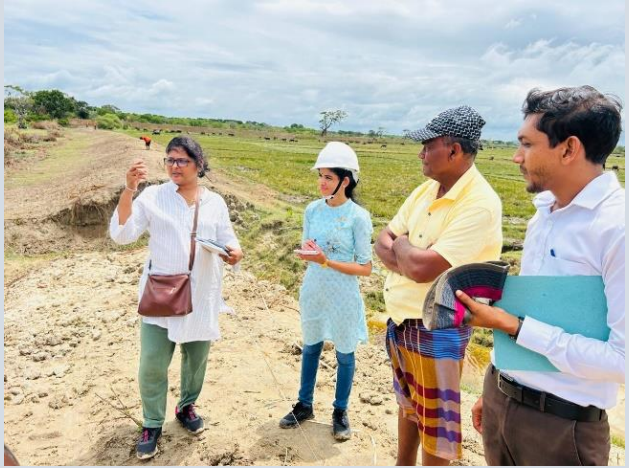
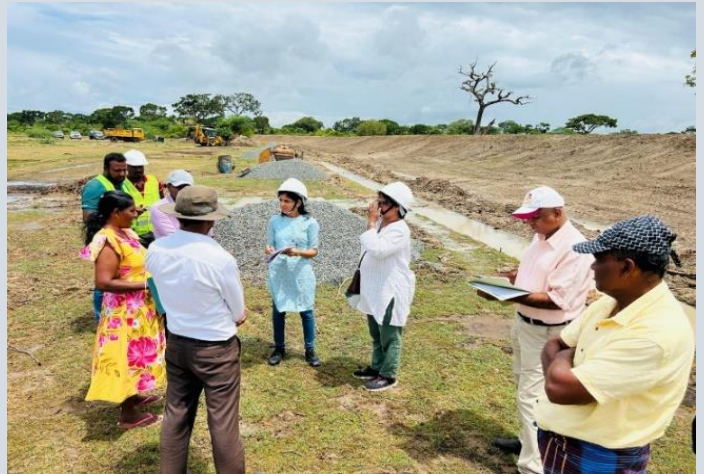
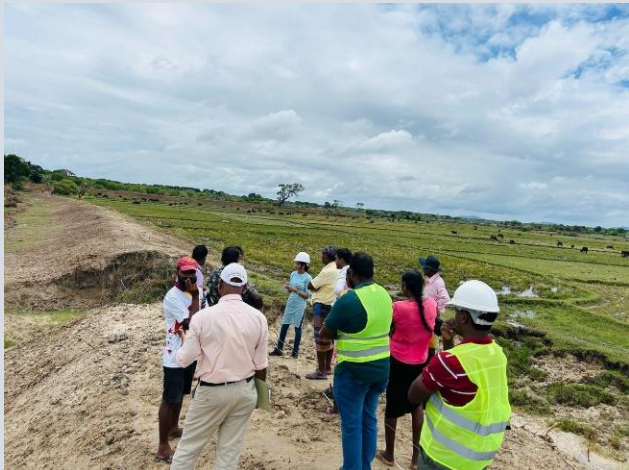
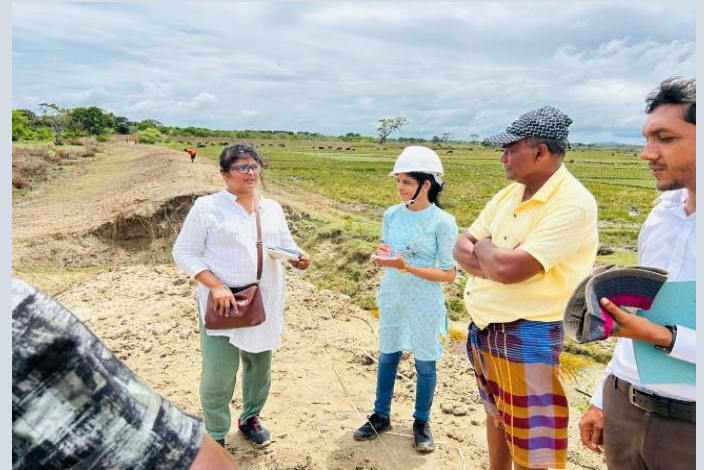
10. SAC Participation and Activity: A five-member Social Audit Committee (SAC) is formed, including 3 male and 2 female farmers. Notably, the two female members are highly active and visit the site daily. Contractors' quality assurance inspector informs SAC members during key construction activities (e.g., concreting), prompting them to visit and monitor quality.

Social Audit Committee (SAC) members should continue to be involved in quality monitoring and reporting processes. Additional training should be provided to SAC members, particularly on the grievance redress mechanism, to enhance their effectiveness in addressing community concerns.

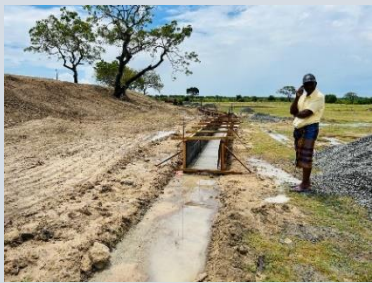
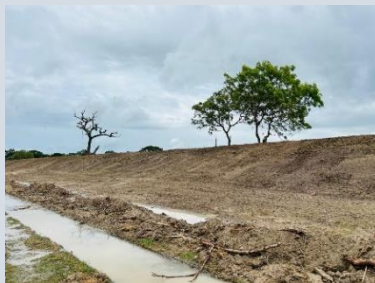
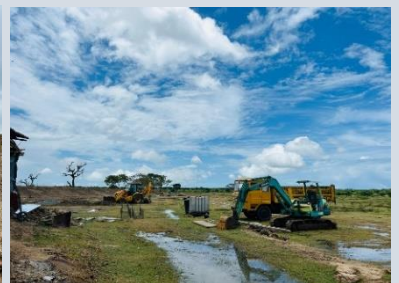
11. Construction Delays Due to Rainfall: Unseasonal heavy rain has significantly impacted work progress. Weather patterns have changed, resulting in more frequent rainy days.

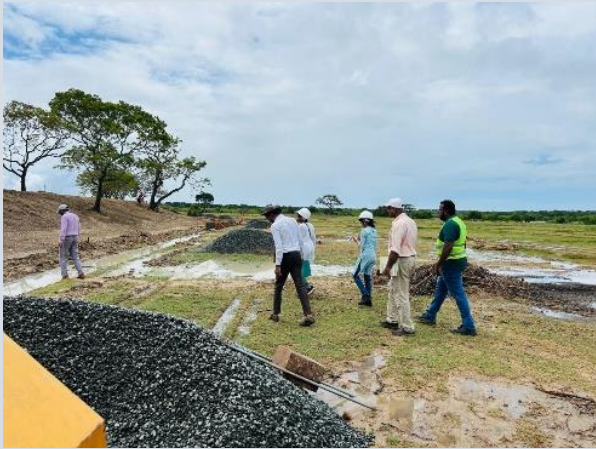
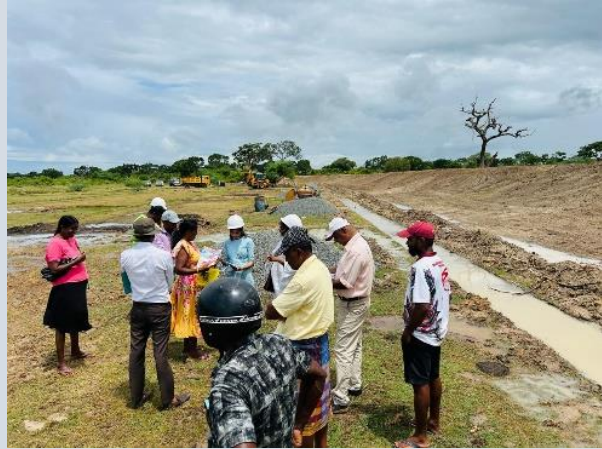
12. Transport and Material Delivery Challenges: Due to waterlogged and inaccessible paths, construction materials are dropped partway to the site, within the wildlife boundary.

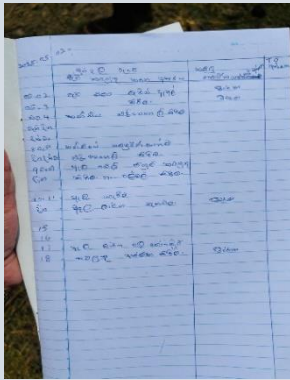
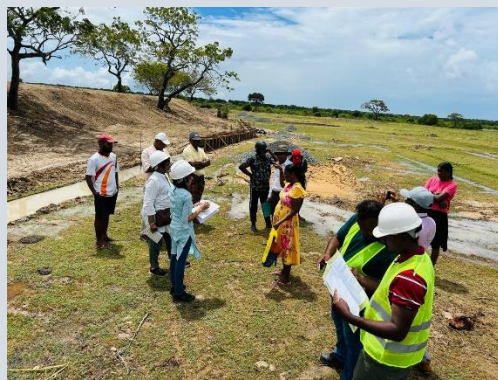
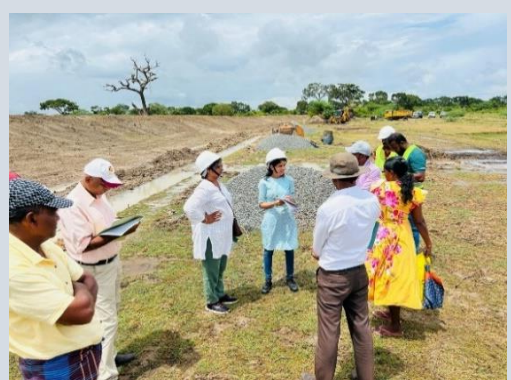
13. The SAC maintains a logbook with daily updates on work progress

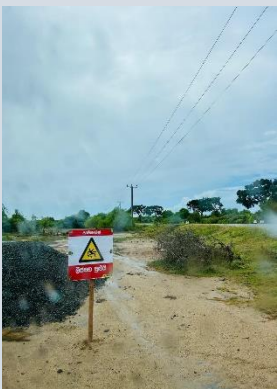
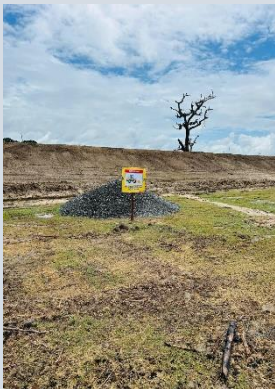
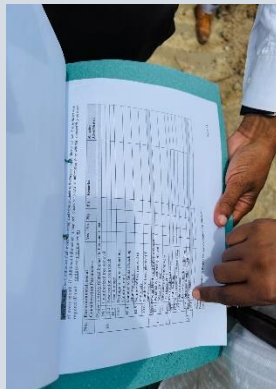
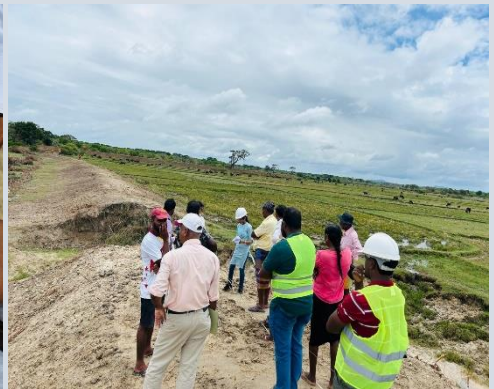
14. Good practices identified include the implementation of Occupational Health and Safety (OHS) measures at the site.

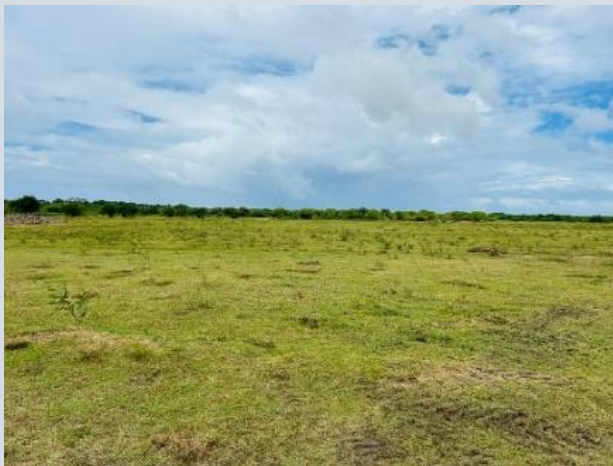
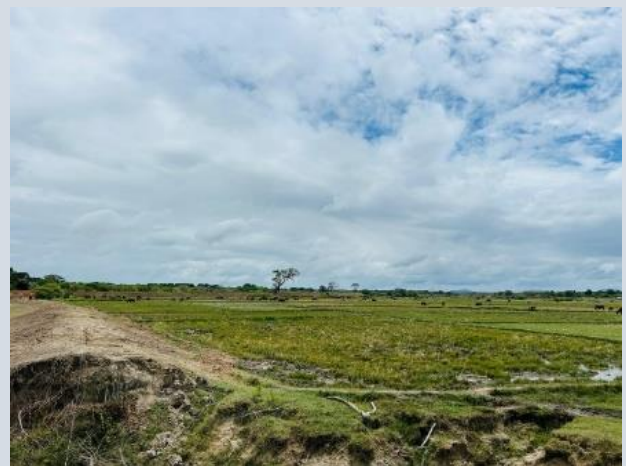
Animals not owned by local residents have caused damage to paddy fields and the tank bund. There is no designated area for animal husbandry, and farmers have identified this as a serious concern. Farmers have successfully harvested the Maha paddy crop and plan to resume Maha, Yala, and mid-season cultivation following the tank's rehabilitation. Although Yala cultivation has not taken place in Bundala Wewa over the past three years, farmers continued cultivation in other nearby tanks. The farming community has expressed appreciation for the selection of this tank for rehabilitation.
