Field Visit Report: Climate Smart Irrigated Agriculture Project (CSIAP) Uva Province

Prepared by Gamini Subasinghe Environment and Social Safeguard Specialist Project Management Unit

Climate Smart Irrigated Agriculture Project (CSIAP) Ministry of Agriculture, Irrigation and Livestock 03.02.2025

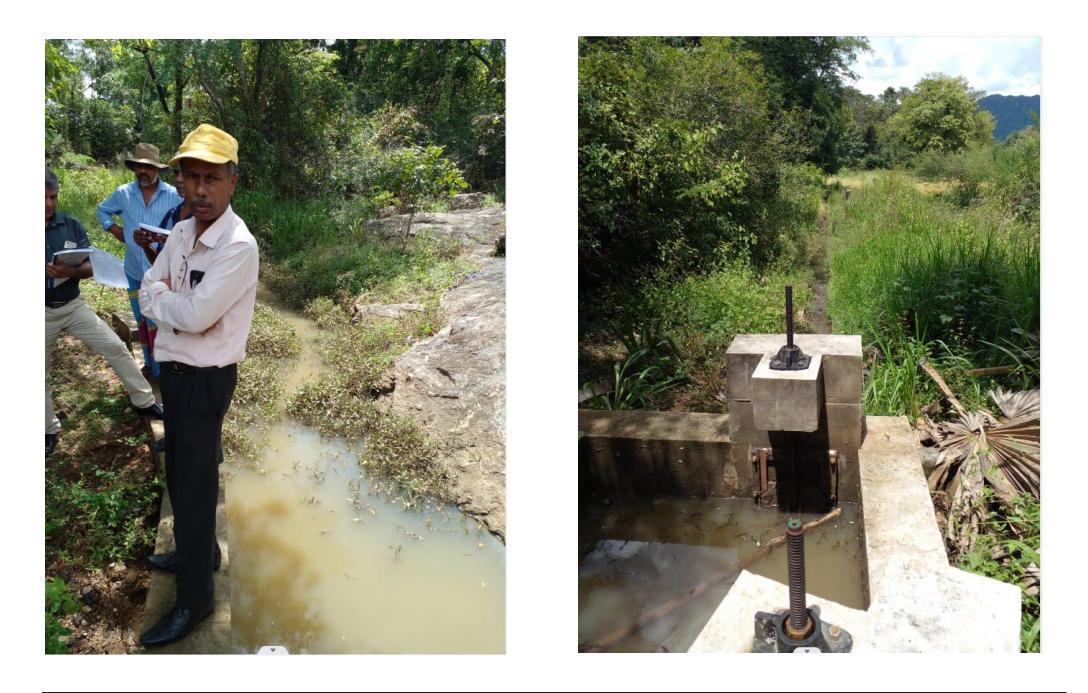
- 1. **Current Status:** 140 m length of the canal rehabilitation is incomplete.
- 2. **Additional Notes:** A canal bund needs to be constructed using soil, and one side of the anicut requires rehabilitation. Elephant damage was noted in the area.

Fig. No. 01: Incomplete Canal rehabilitation under Dambakotu Ara Anicut Rehabilitation

Completion of Canal Rehabilitation (balance 140 m Length)-Prioritize the completion of the 140 m length of canal rehabilitation by engaging a qualified contractor with experience in similar projects. Develop a detailed project timeline and ensure that regular progress assessments are conducted to keep the project on track. Allocate necessary resources and funding to expedite completion.

Construction of Canal Bund- Design and construct a canal bund using appropriate soil materials to enhance water retention and prevent erosion. The design should include considerations for local topography and hydrology to ensure effectiveness. Involve local stakeholders in the planning process to address any community concerns and ensure the bund meets agricultural and environmental needs.

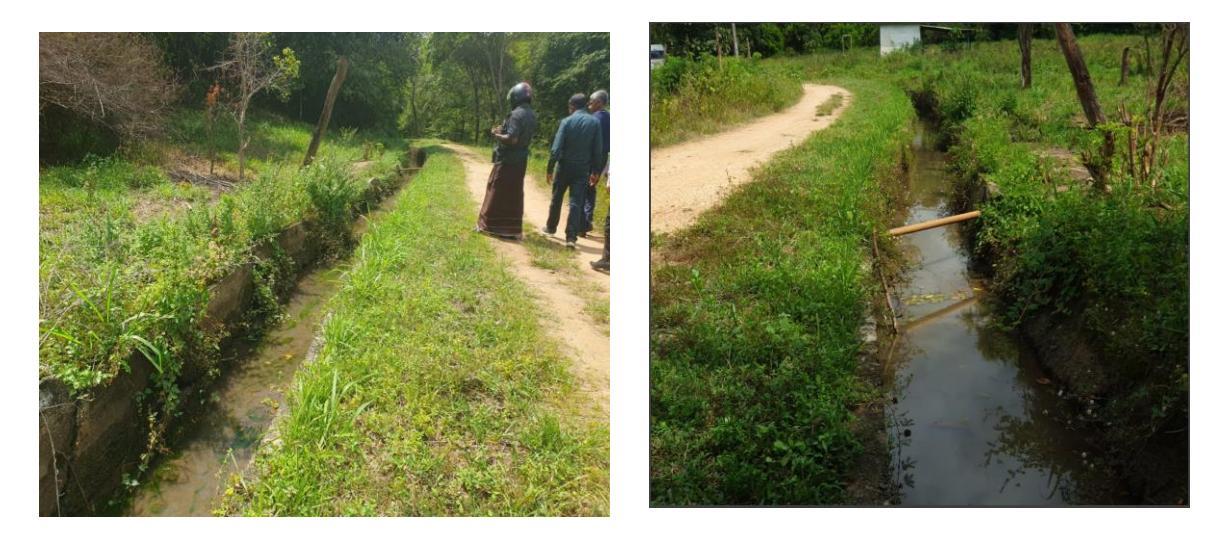
1. **Required Work:** Removal and replacement of existing concrete from both sides of the canal with new concrete or geotextile lining.

Fig. No. 01: Need for Tree Planting for both sides of the canal & Fig. No. 02: Need for Removal and Replacement of Existing Concrete

- As part of ESMP implementation for Karuwala Kanda Wewa, the concrete disposal sites need to be identified. It was suggested to plant arecanut trees along both sides of the canal to enhance vegetation, prevent soil erosion, and reduce soil collapses into the canal.
- The sluice needs to be raised to ensure proper operation and maintenance, thereby preventing wild animals from falling into the canal.
